# **INDOOR AIR QUALITY ASSESSMENT**

**L.D. Batchelder Elementary School  
2 Peabody Street  
North Reading, Massachusetts**

Prepared by:  
Massachusetts Department of Public Health  
Bureau of Environmental Health Assessment  
March, 2001

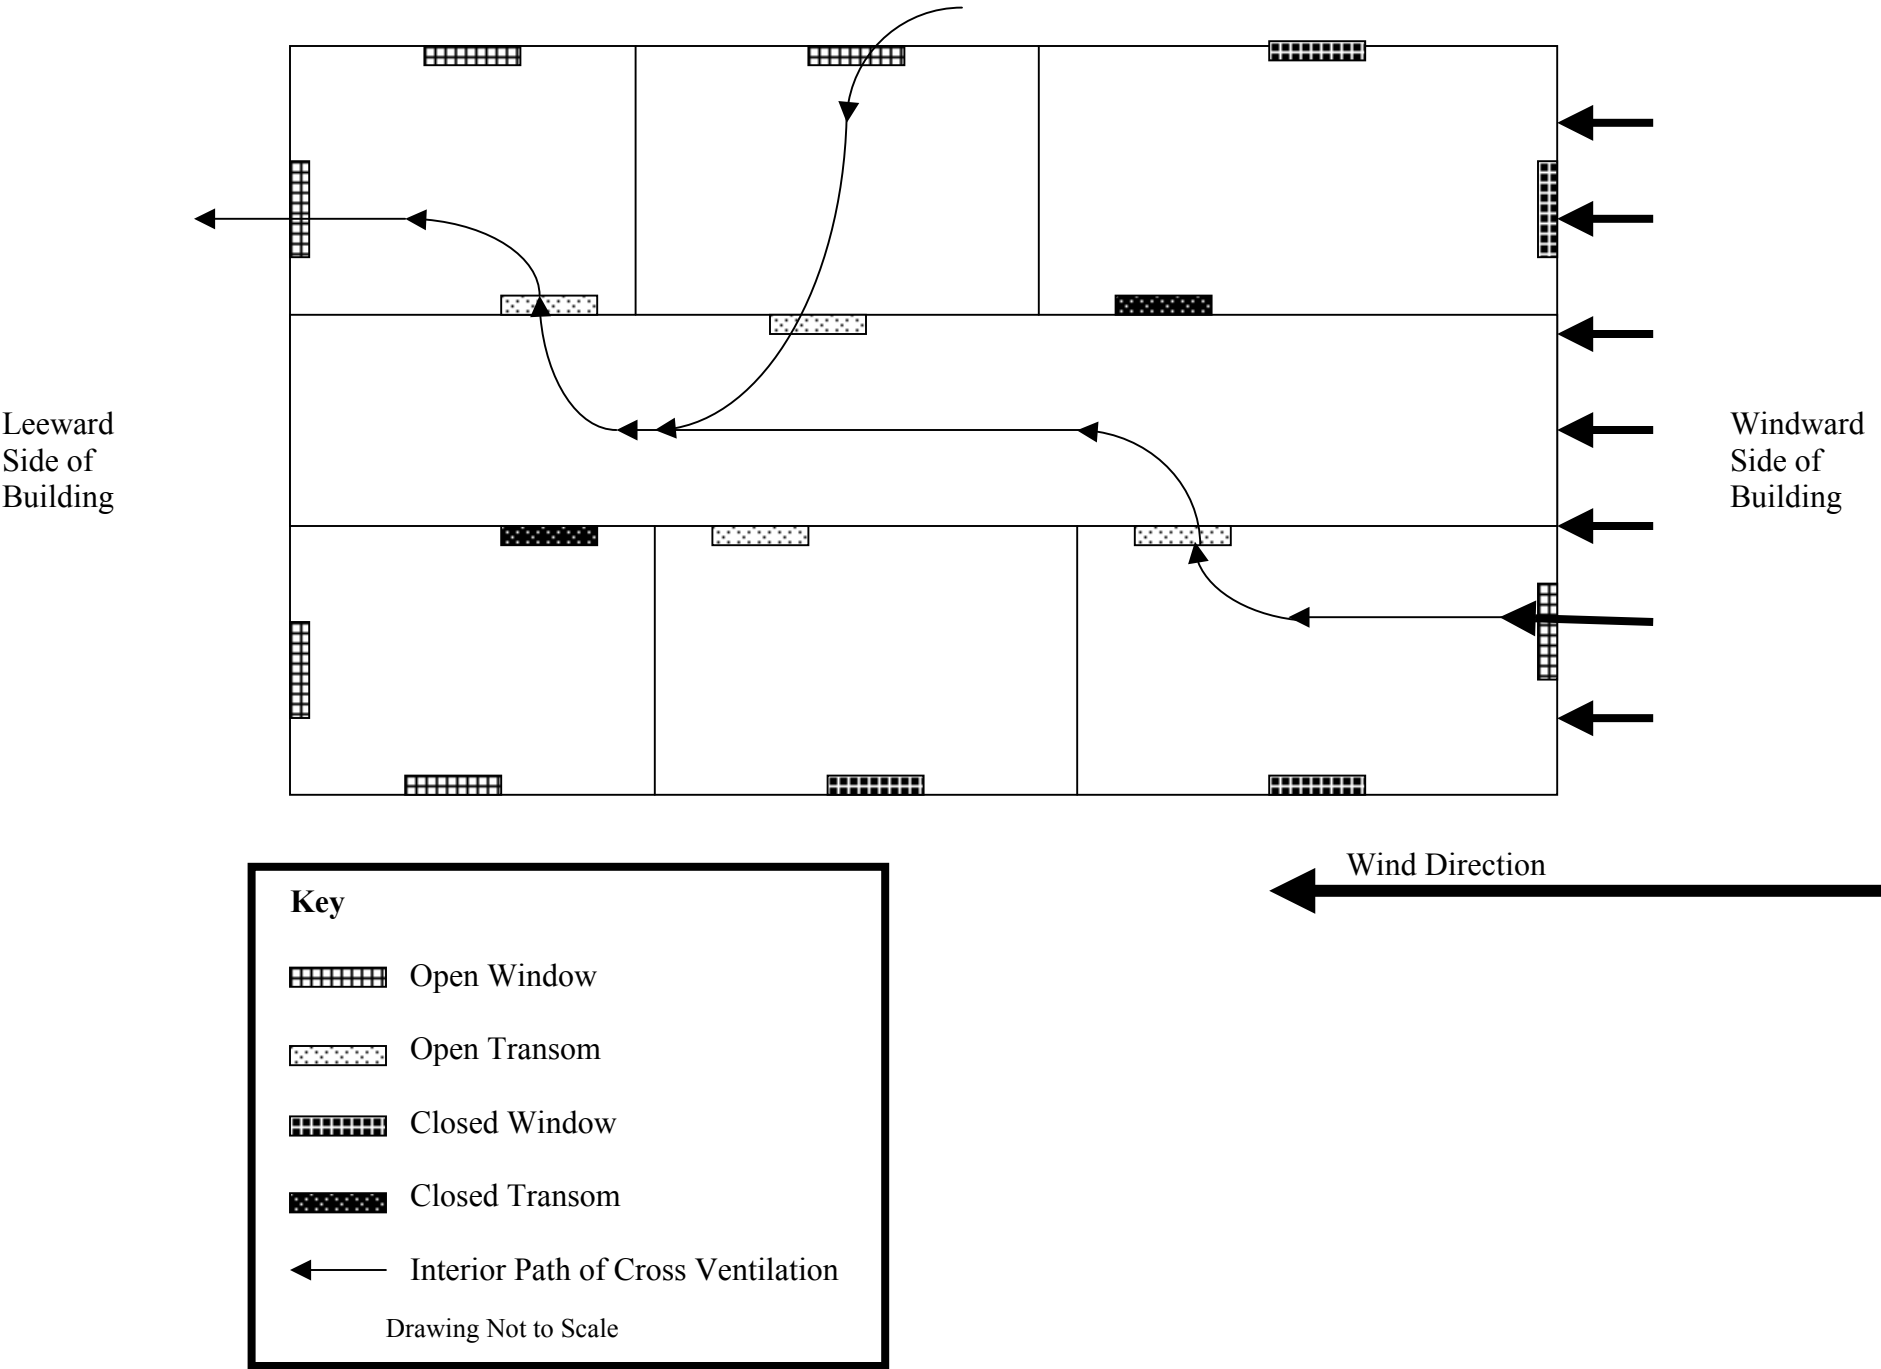
Figure 3

addition, the building has hinged windows located above the hallway doors. This hinged window (called a transom) (see Picture 5) enables classroom occupants to close the hallway door while maintaining a pathway for airflow. The design allows for airflow to enter an open window, pass through a classroom and subsequently pass through the open transom. Airflow then enters the hallway, passing through the opposing open classroom transom, into the opposing classroom and finally exits the building on the leeward side (opposite the windward side) (see Figure 2). With all windows and transoms open, airflow can be maintained in a building regardless of the direction of the wind. This system fails if the windows or transoms are closed (see Figure 3). Transoms are opened using a rod/hinge system. Most transoms in these wings are inoperable. The doorframes appear to have been painted, resulting in the repeated coating of the transom control rods.

Inhibition of Cross Ventilation in a Building with Several Windows and Transoms Closed
